Paper Mill, Central Ohio (1995)

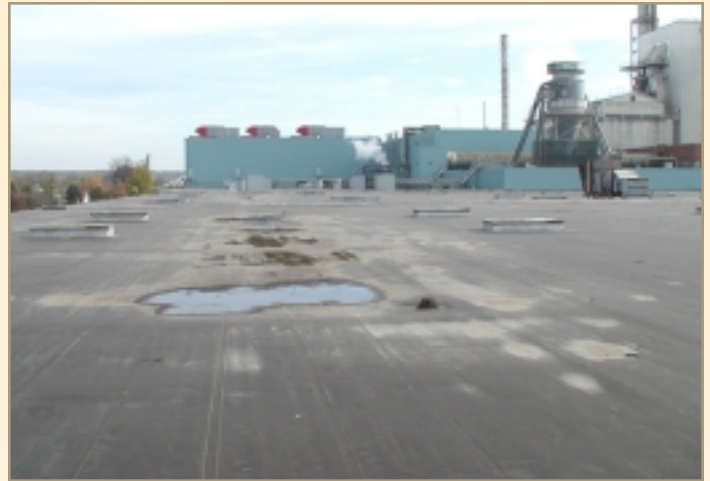
It had been over a week since the last rainfall when this picture was taken. The years of ponding water and accompanying debris accumulated on the Hyload membrane has not caused any damage.

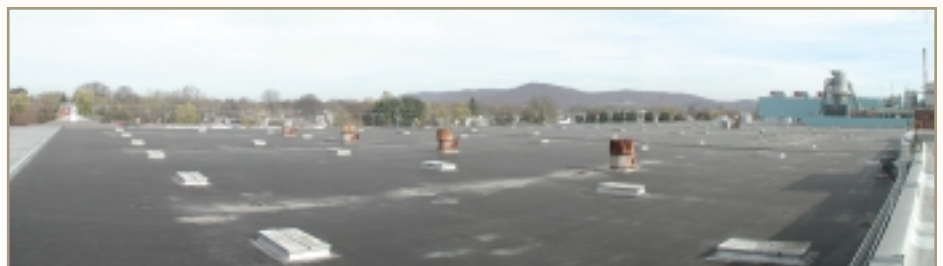
This finished product warehouse at a paper mill in Ohio has 220,000 square feet of trouble-free roof.
